MISCELLANEOUS PAPER CERC-92-10

ENGINEERING ASSESSMENT OF HYDRODYNAMICS AND JETTY SCOUR AT LITTLE RIVER INLET NORTH AND SOUTH CAROLINA

Final Report

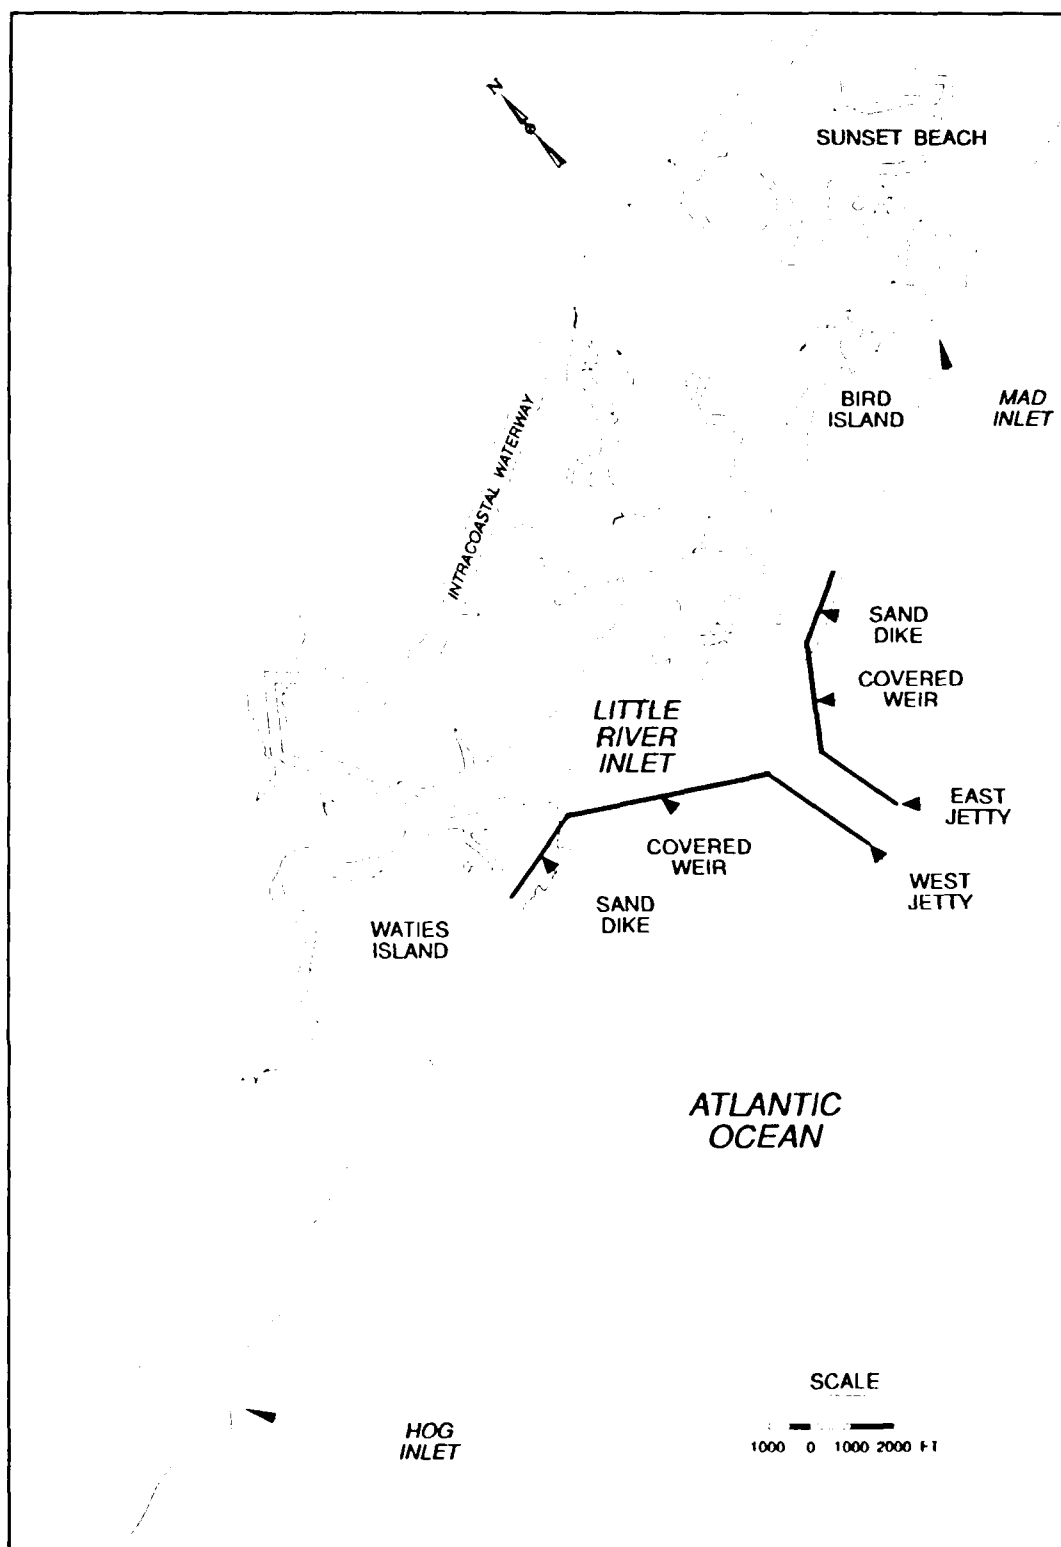
Figure 2. Little River Inlet navigation project and vicinity

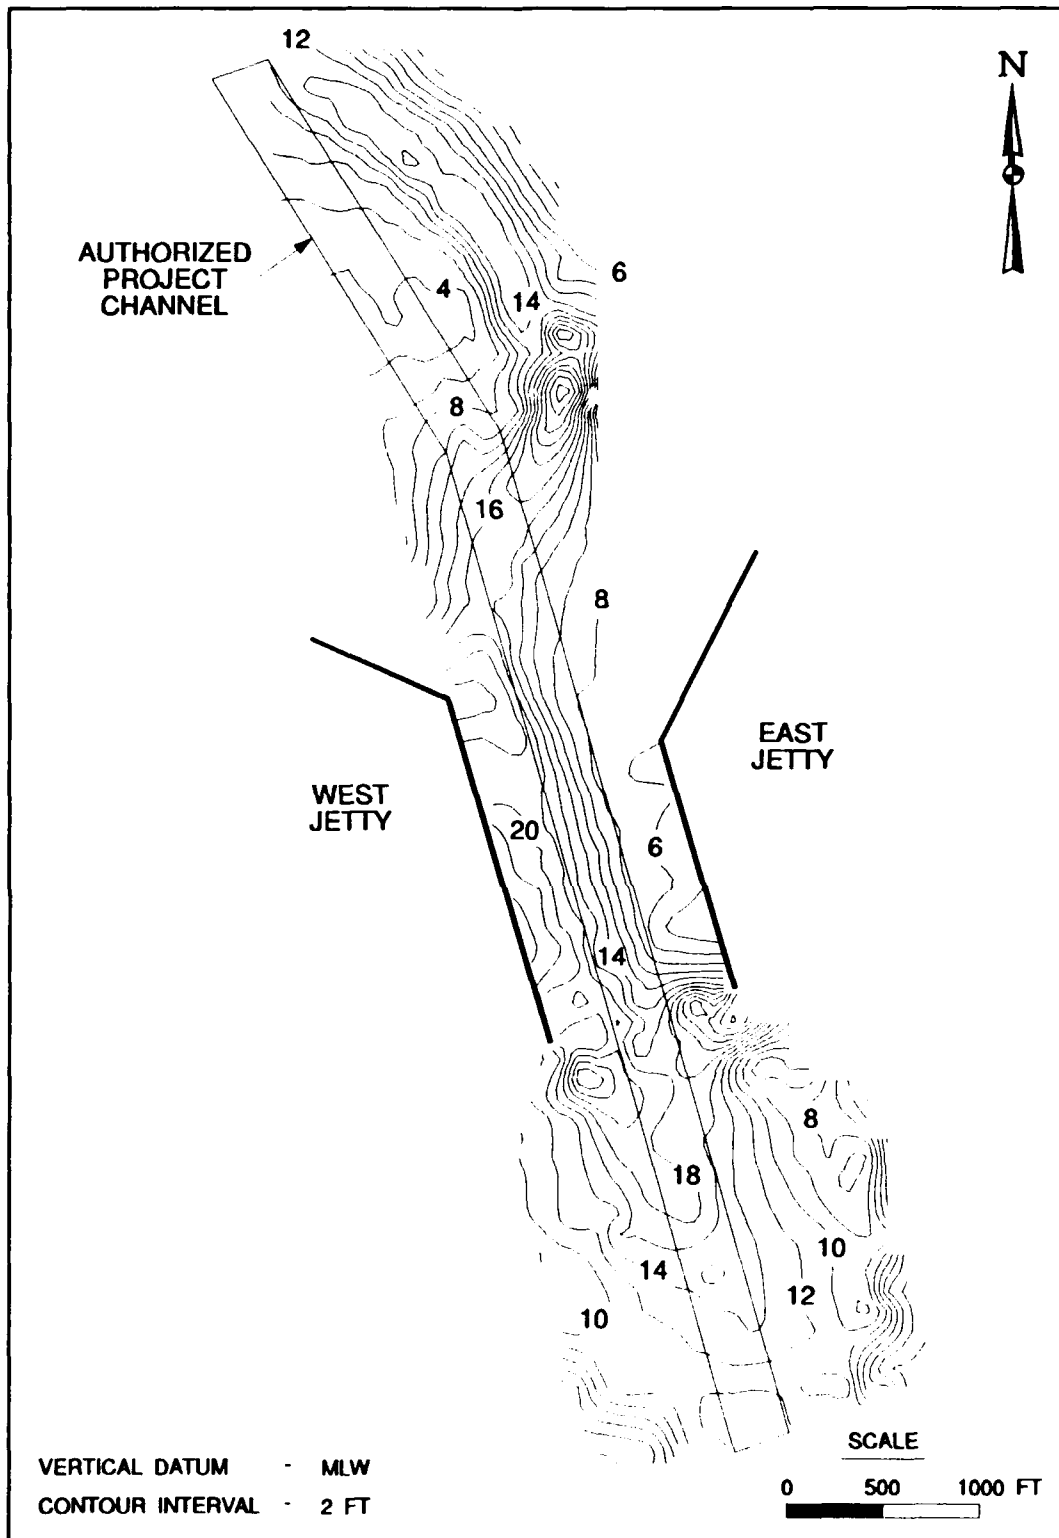
Figure 4. Channel migration and locations of scour at the Little River Inlet jetties

jetty tip began around October 1982 and increased to depths greater than 25 ft MLW by April 1983 (Figure 58). A slight increase in depth also was evident at the east jetty bend. These deepening trends have continued (Figures 59 to 61). Note the increase in depths on the left side of Figures 59 and 60. The base point for Profile Line 27 lies within the naturally deep area (inlet gorge) described in Figure 4 and shows movement of that hole slightly seaward.

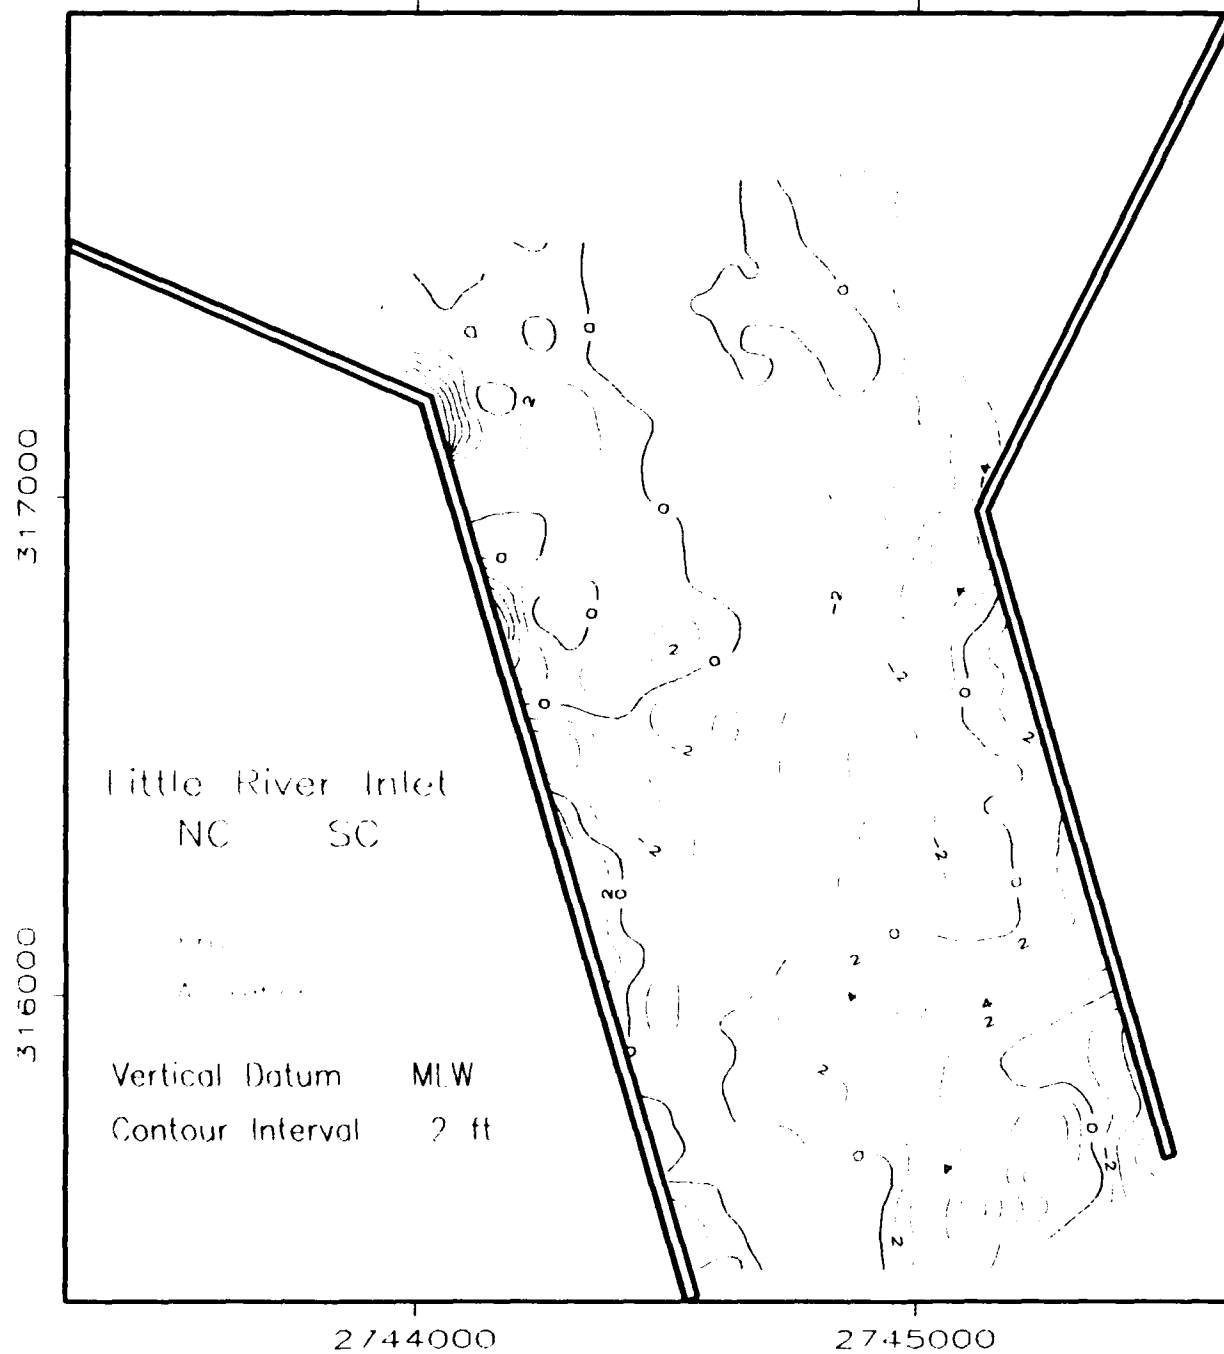
Figure 19. Contour difference map: June 1990 to June 1991

53. The area in the vicinity of the east jetty bend began to increase in depth more rapidly between the June 1990 and 1991 condition surveys (Figures 13 to 17, and 19). It appears that storm surge and wave action due to Hurricane Hugo in September 1989 may have expanded the area of and accelerated the deepening trend evident in this area prior to the storm. Additionally, the inlet-facing shoreline of Bird Island, which had accreted significantly since jetty construction, also began to erode significantly from November 1989 to the present (Figure 62). Visual observations made during the May 1991 field investigation indicated significant and active scarping of this shoreline, which lies adjacent to and drops off relatively steeply into the natural gorge area. Bird Island shoreline erosion is most likely due to deeper bathymetry near the east jetty bend, and movement of flow toward a more central location through the inlet (that is, closer to the east jetty and Bird Island).

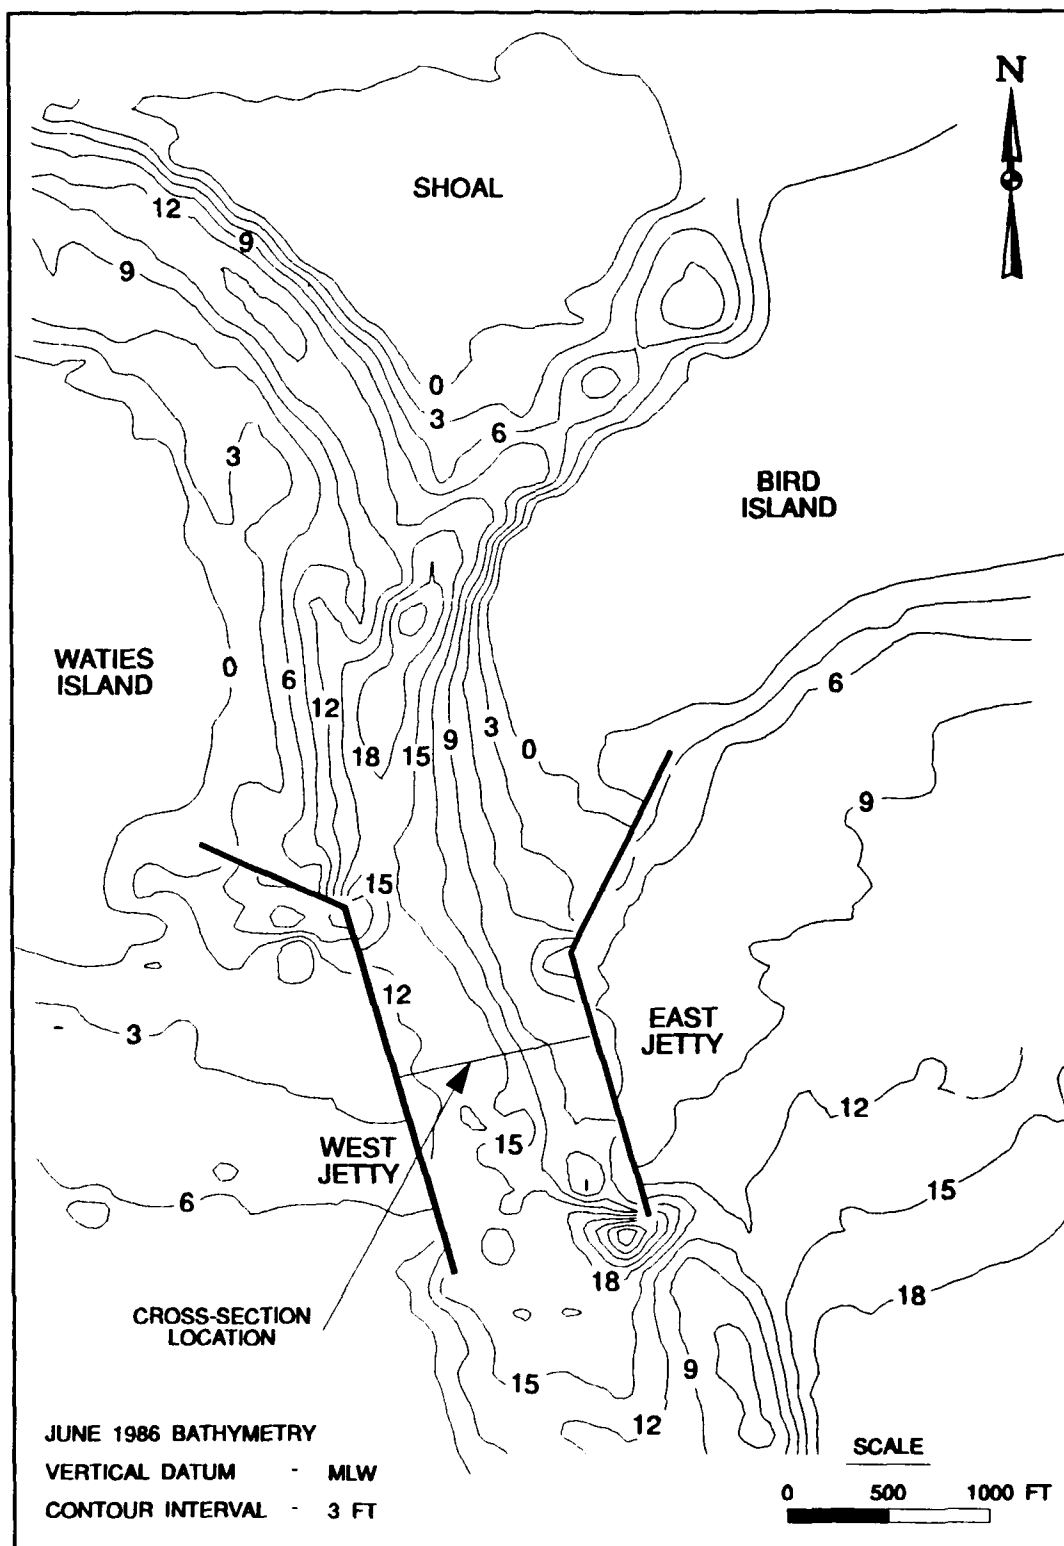
Figure 20. Location of profile used to calculate cross-sectional areas

27. Cross-sectional areas were computed for each survey data set along the cross-sectional profile designated in Figure 20. Although the calculated areas represent changes across only one section of the inlet channel, they allow a rough estimate of changes in stability across that portion of the channel. Channel cross-sections for each date were depicted using CPS-3, and then areas (to MLW) were digitized and computed using the CALCOMP 9000 system (Table 2). The area at this location has gradually increased over the period between 1983 and 1991; however, these are not considered major increases relative to accuracy of methods used to calculate the values. This analysis indicates that the inlet cross-section is still changing and has not yet reached a long-term equilibrium condition.

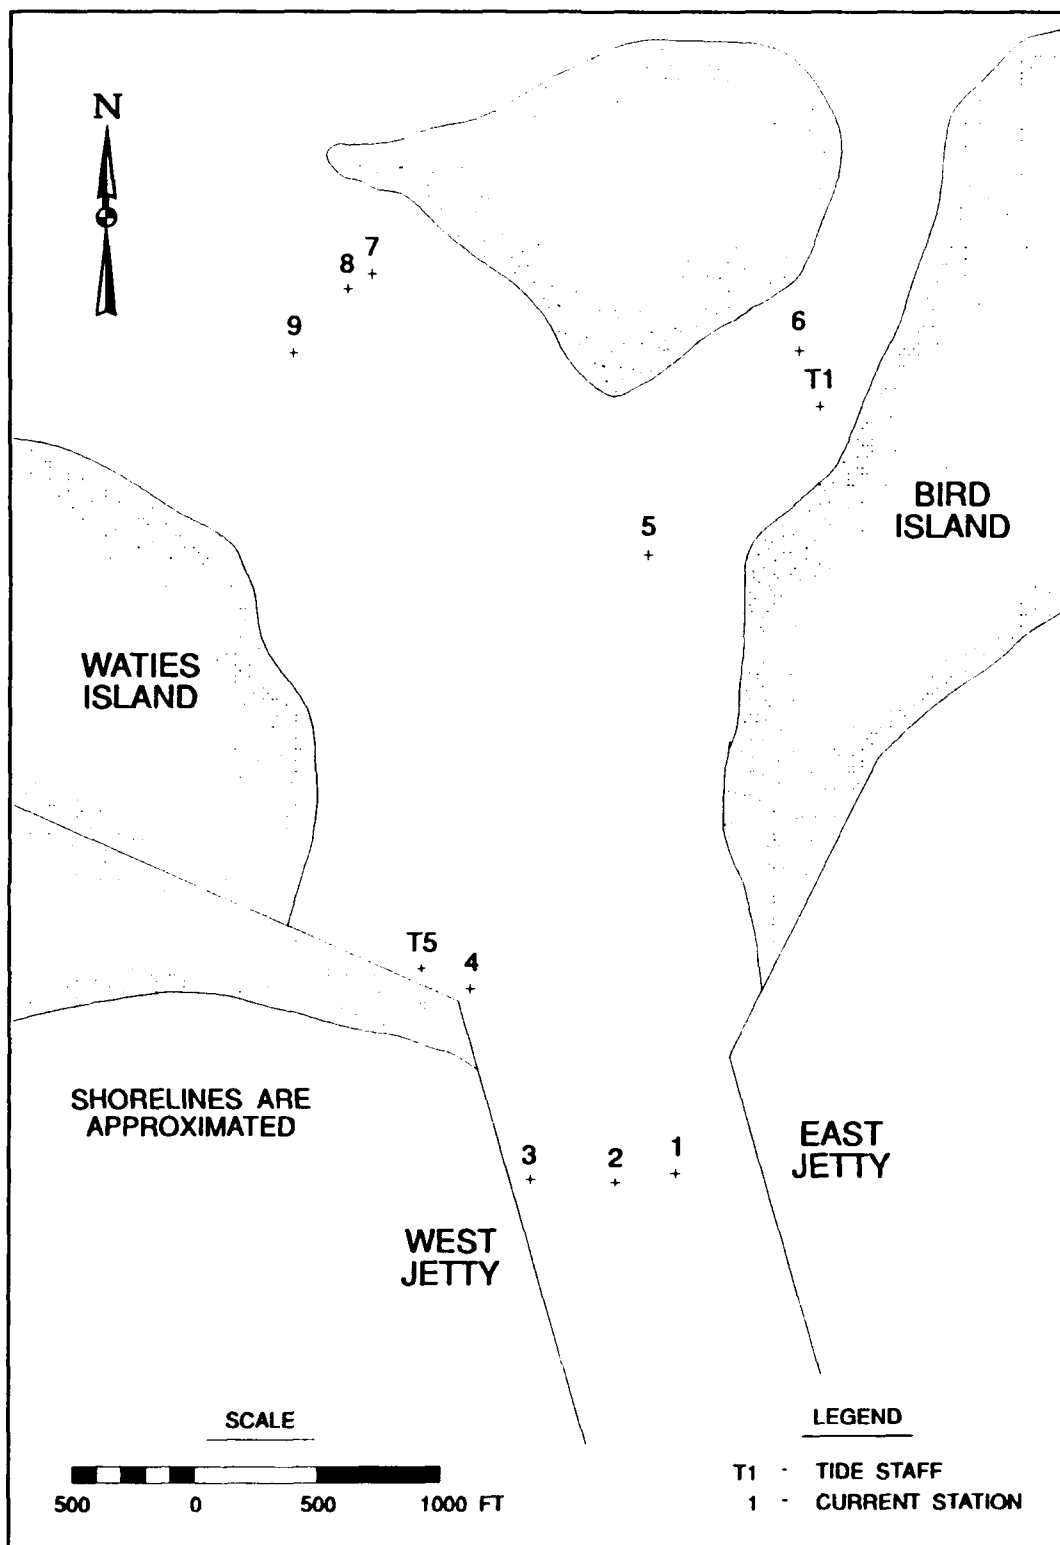
Figure 21. Stations used for tidal current monitoring

31. On 22 May 1991, vertical profiles of current speed and direction were measured at nine stations between the jetties and across the two channels leading into the inlet (Figure 21). Measurements were taken at two to three different depths (bottom, middle, and surface), and were obtained at approximately 1-1/2-hr intervals over a 13-hr time period. Stations 4 and 5 were monitored to determine flow patterns and scour currents through these deeper areas, especially at peak flood and ebb tides. Navigation conditions prevented collecting current data at the east jetty tip scour hole.

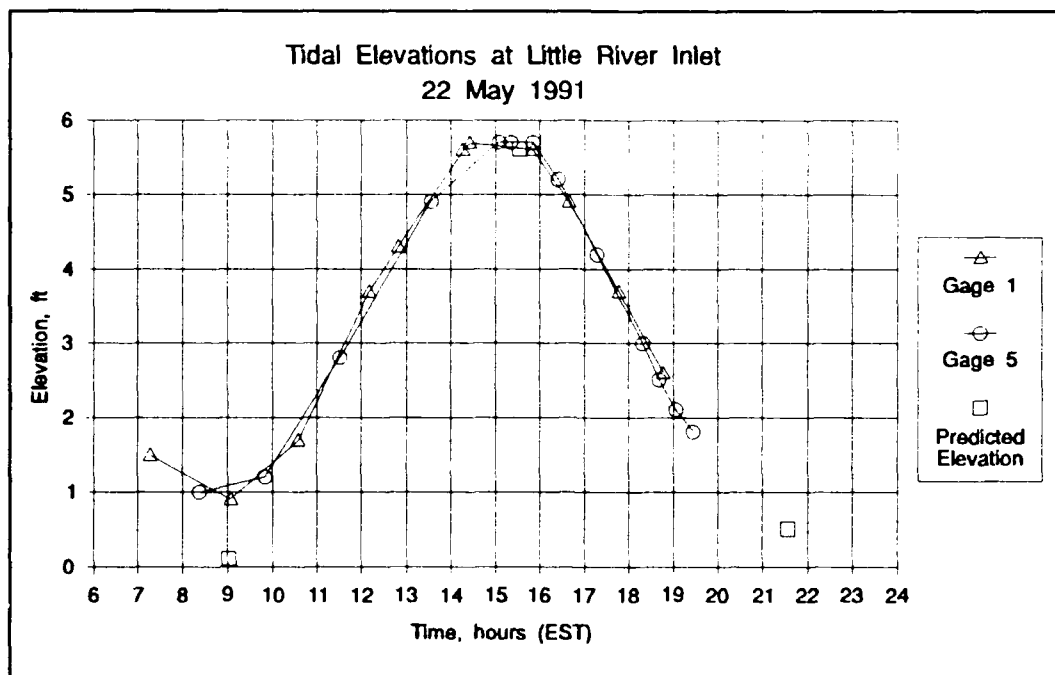
Figure 22. Measured and predicted tides, 22 May 1991

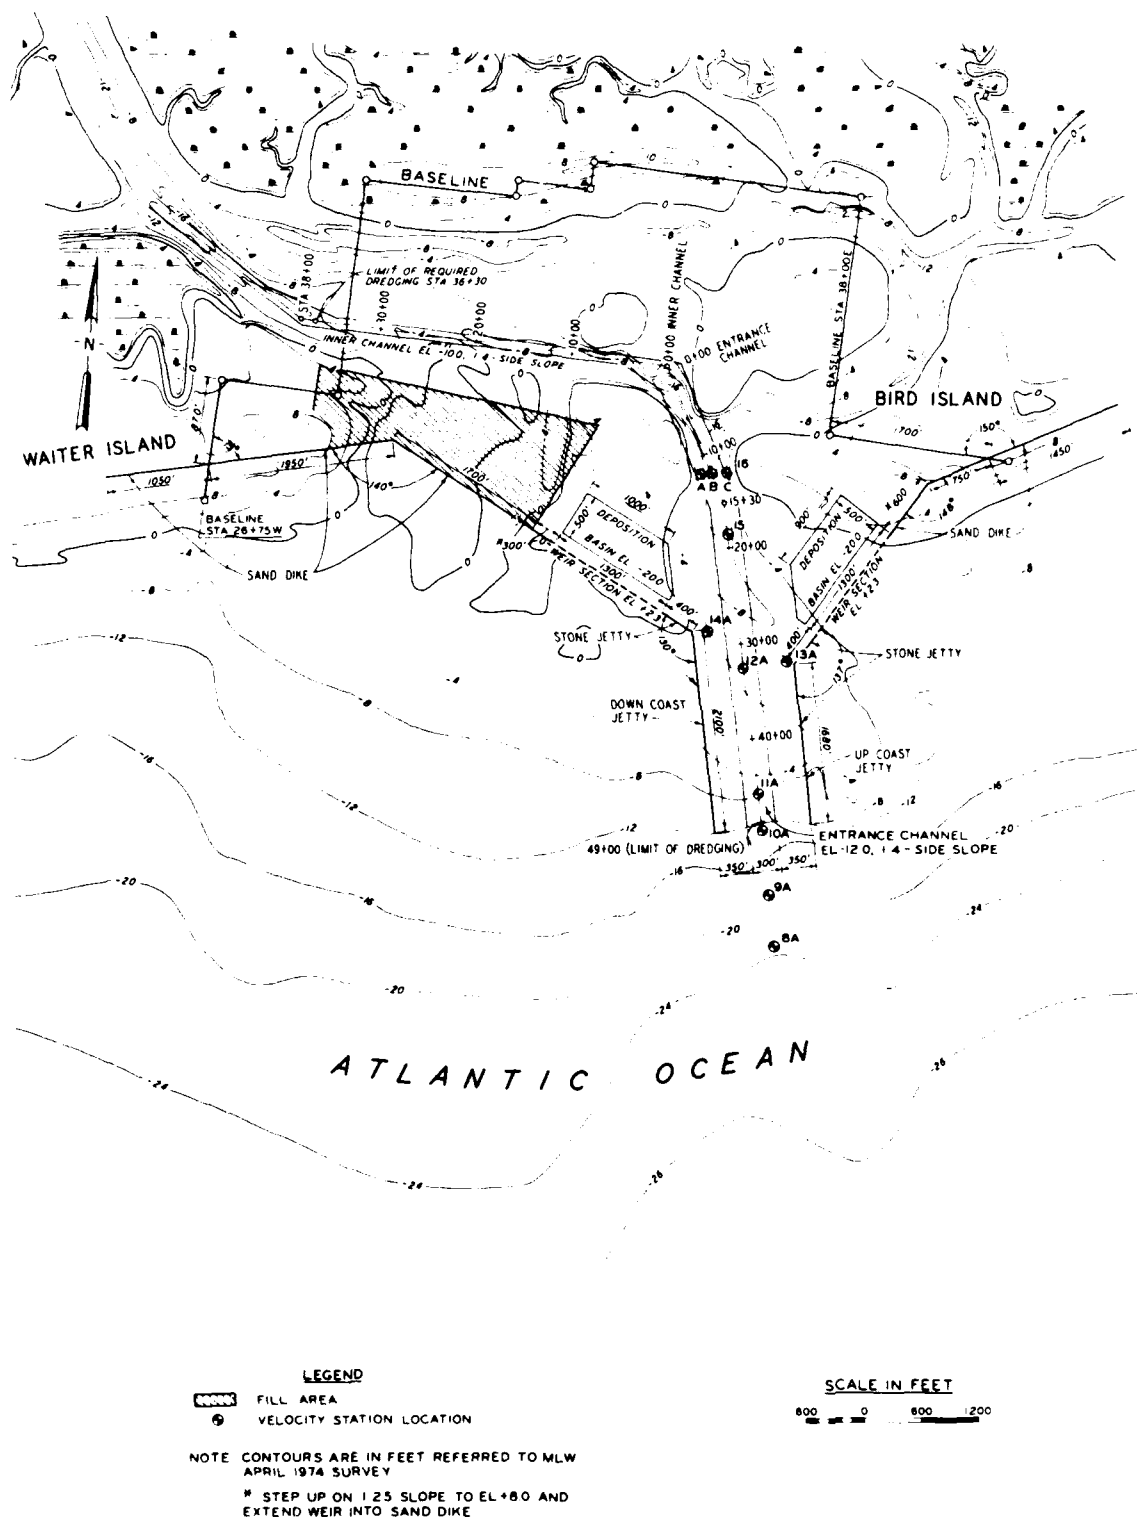
Figure 41. Jetty and channel alignment for Plan 2D
(from Seabergh and Lane 1977)

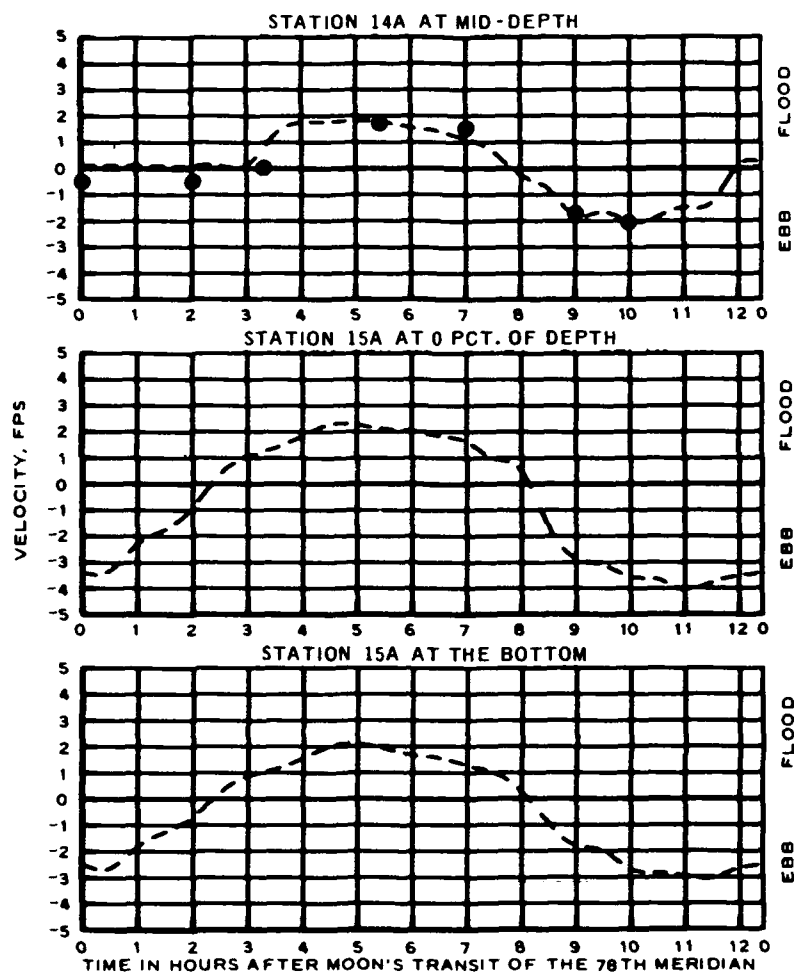
TEST CONDITIONS
OCEAN TIDE RANGE = 5.0 FT

Figure 43. Effects of Plan 2D on velocities (from Seabergh and Lane 1977)

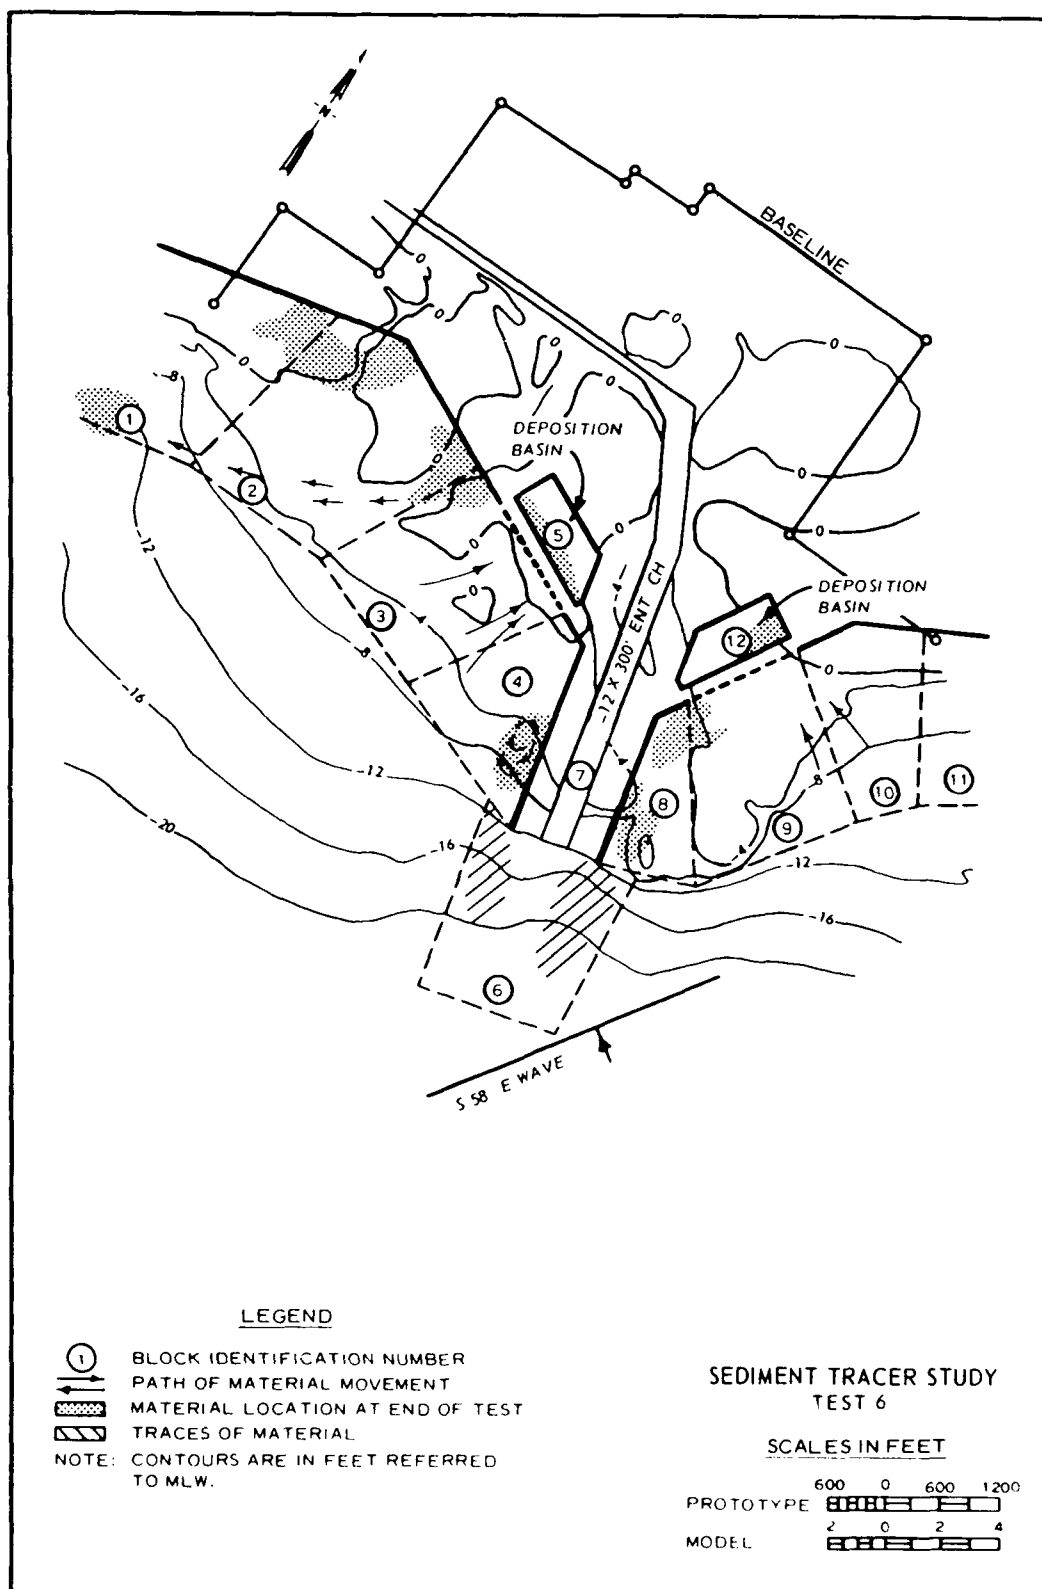
Figure 49. Results of the sediment tracer study
(from Seabergh and Lane 1977)

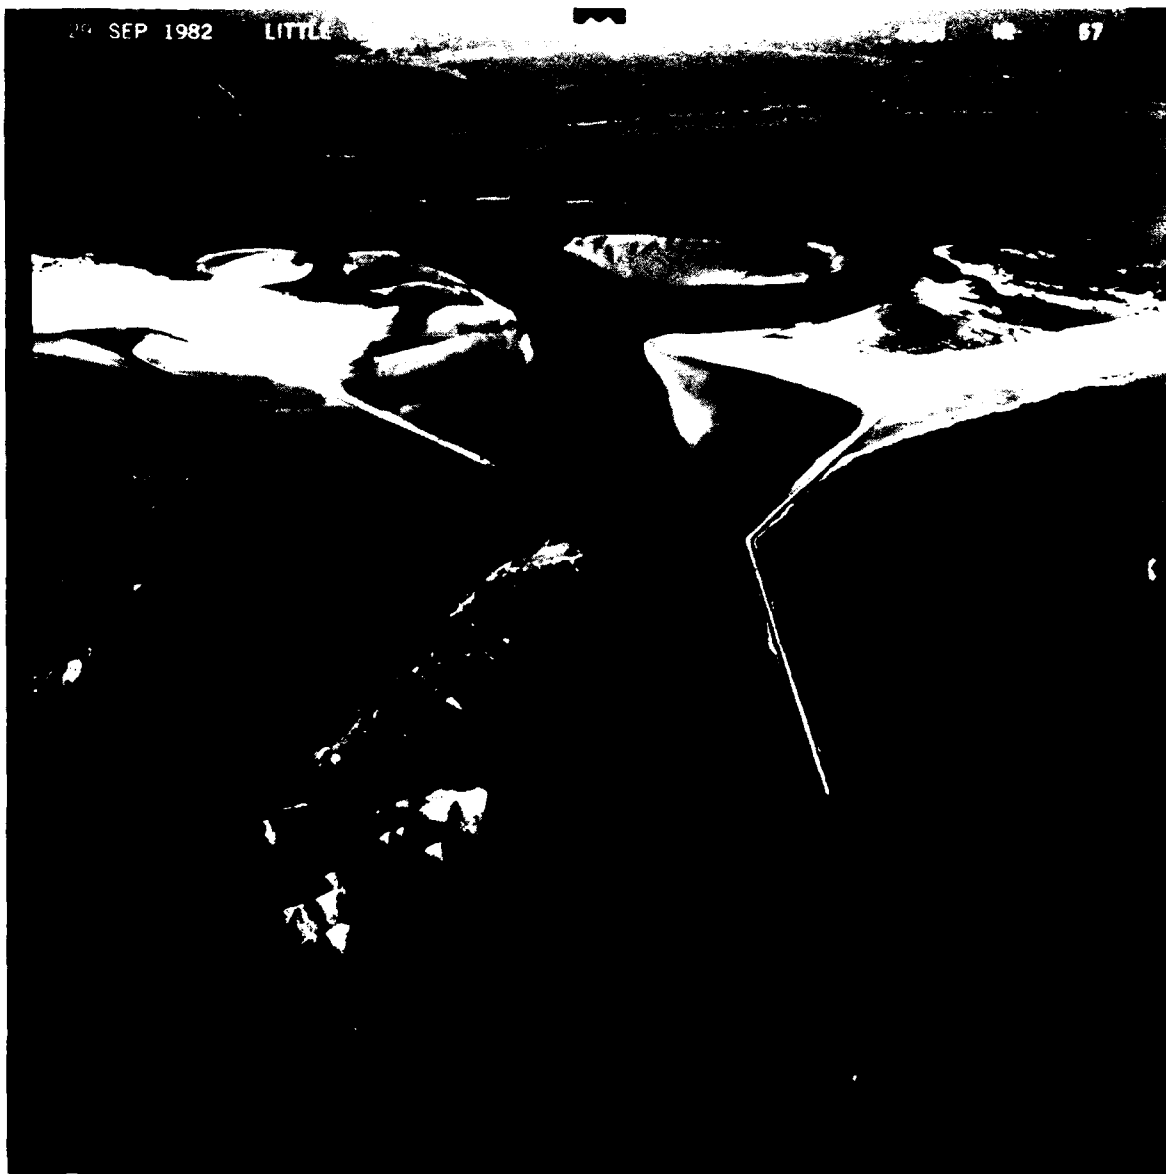
Figure 50. Aerial photography showing channel configuration during construction of the west jetty: September 1982

56. The deeper waters and subsequent scour which exist along the west jetty have been described in a previous section as a function of the historical thalweg position at the time of project construction (Figure 50). Since the jetties were completed, the channel thalweg has typically run north of the authorized channel in the upper reaches, swinging through the deep hole located at the bifurcation point of the main channel, then flowing back across the inlet and along the west jetty. It appears; however, in more recent condition surveys (1990 to 1991), that certain hydrodynamic and bathymetric conditions are undergoing changes in the inlet. These changes may have been accelerated by the occurrence of Hurricane Hugo in September 1989.

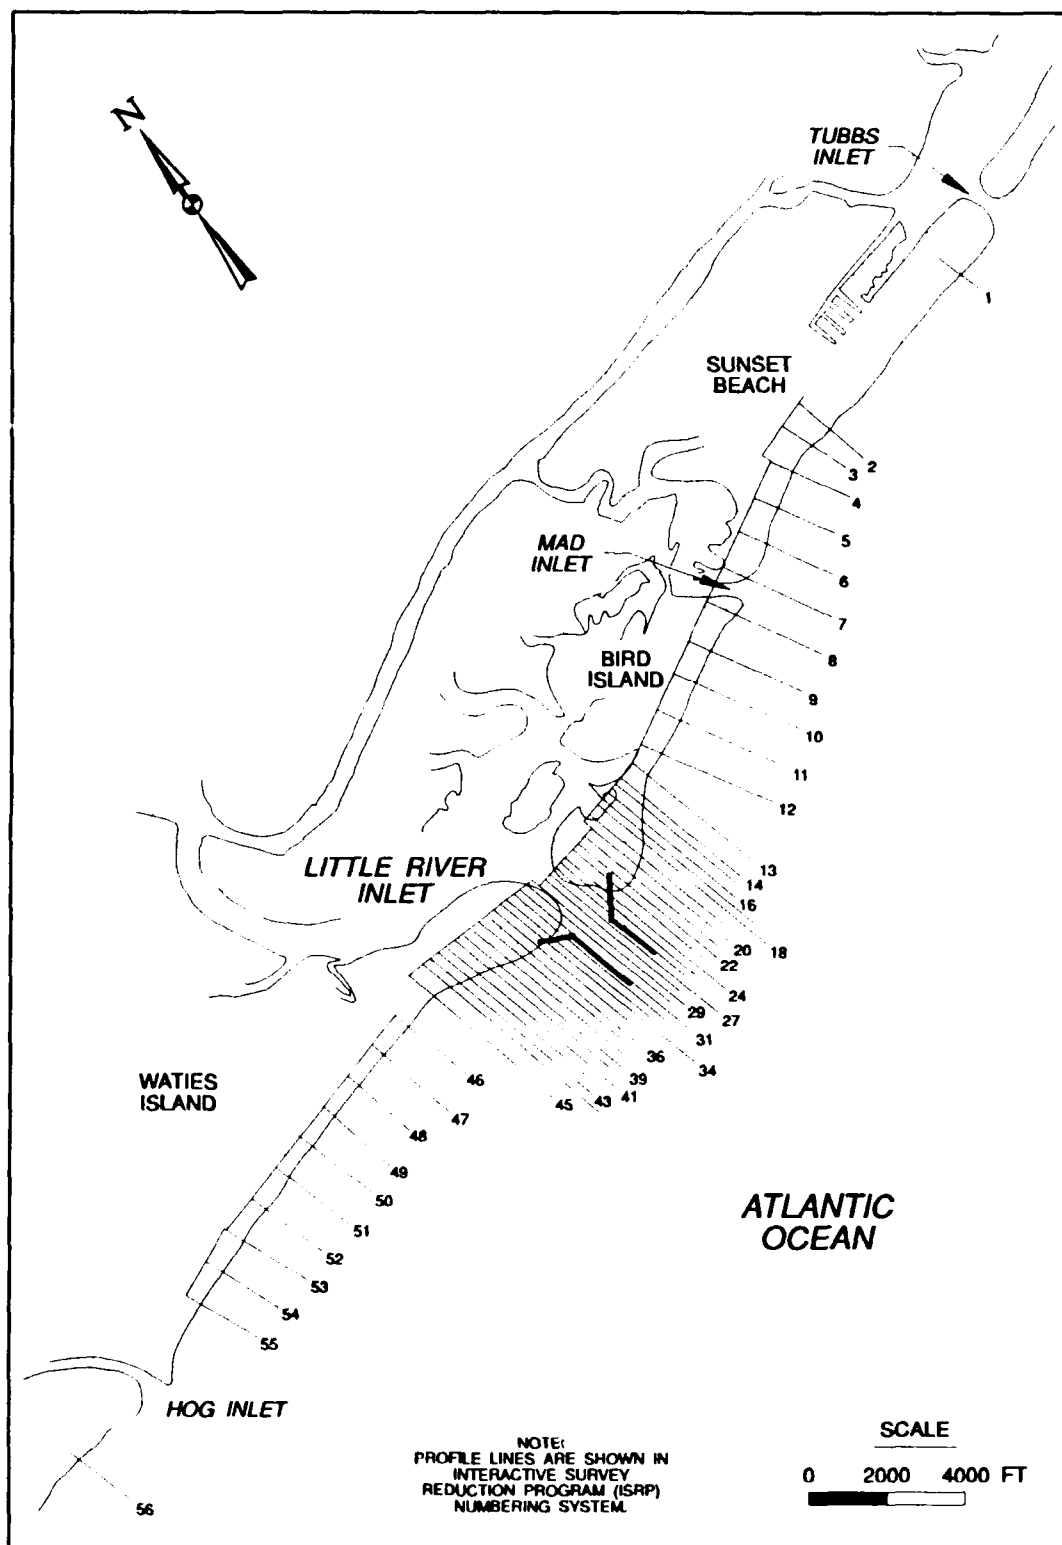
Figure 51. Little River Inlet profile lines

52. Profile Line 27, referred to in Figures 58 through 61, lies immediately to the west of the east jetty (see Figure 51). Scour at the east

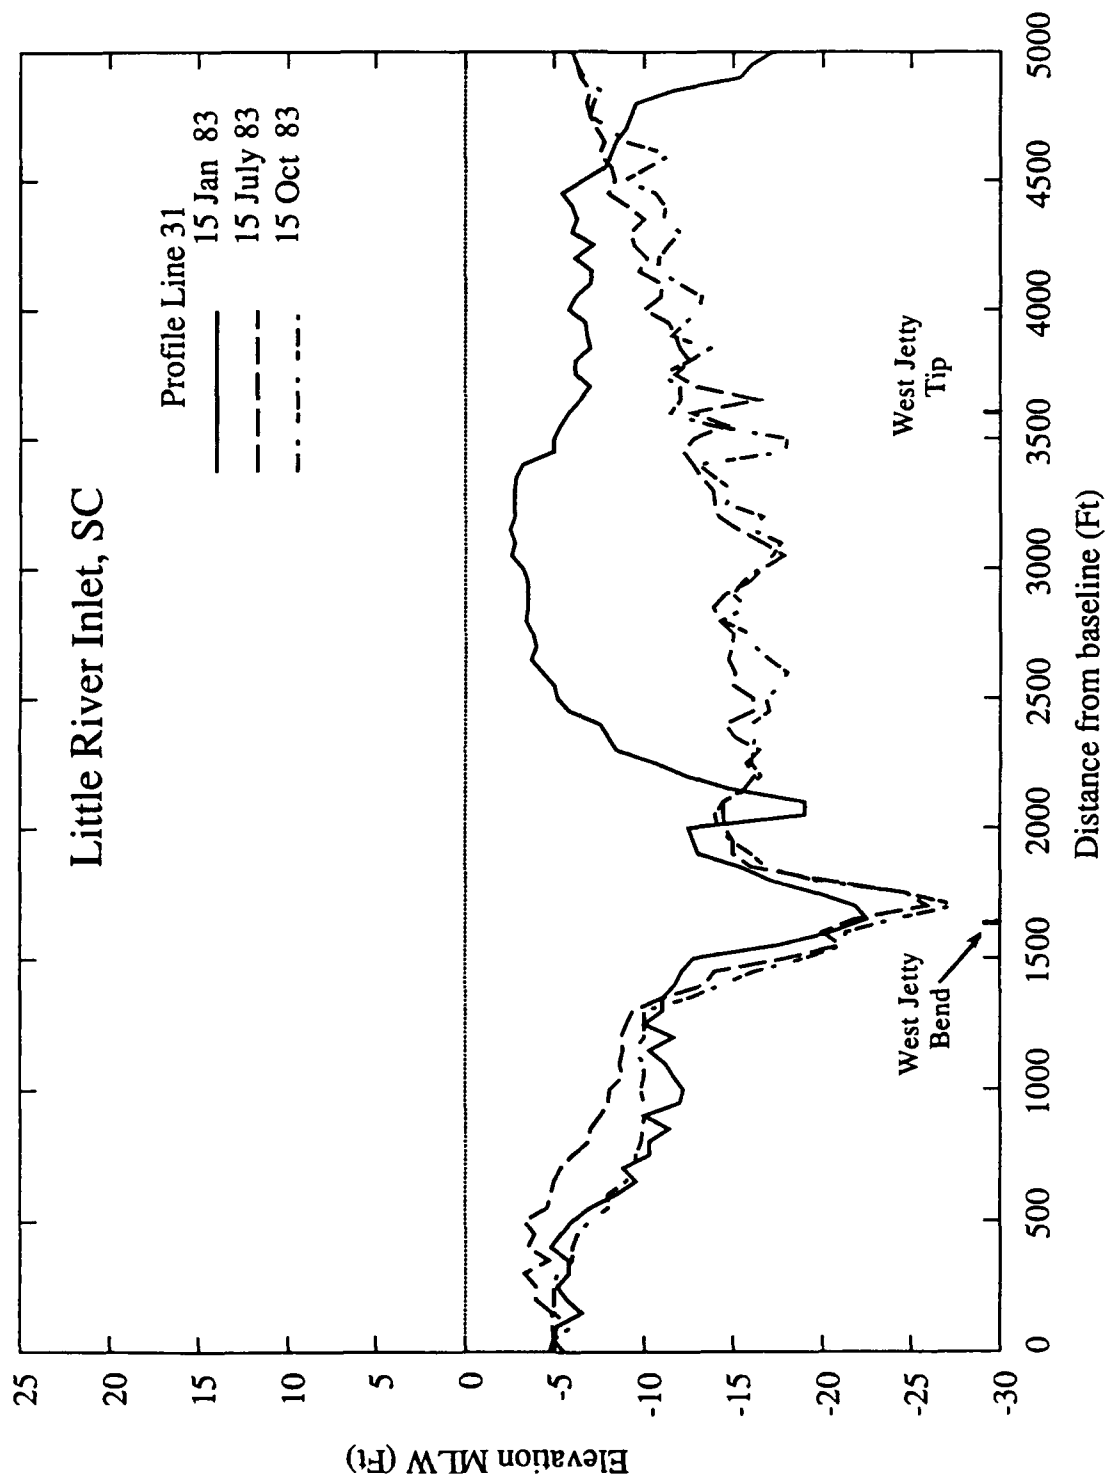
Figure 52. Profile along inside of west jetty: January to October 1983

50. Construction of the west jetty was completed by July 1983. By the November 1983 condition survey, deepening along the west jetty on the order of 15 to 18 ft MLW had already begun to occur. Along Profile Line 31, which lies immediately east of the jetty (Figure 51), maximum depths of 20 to 25 ft MLW were evident at the jetty bend (Figure 52).

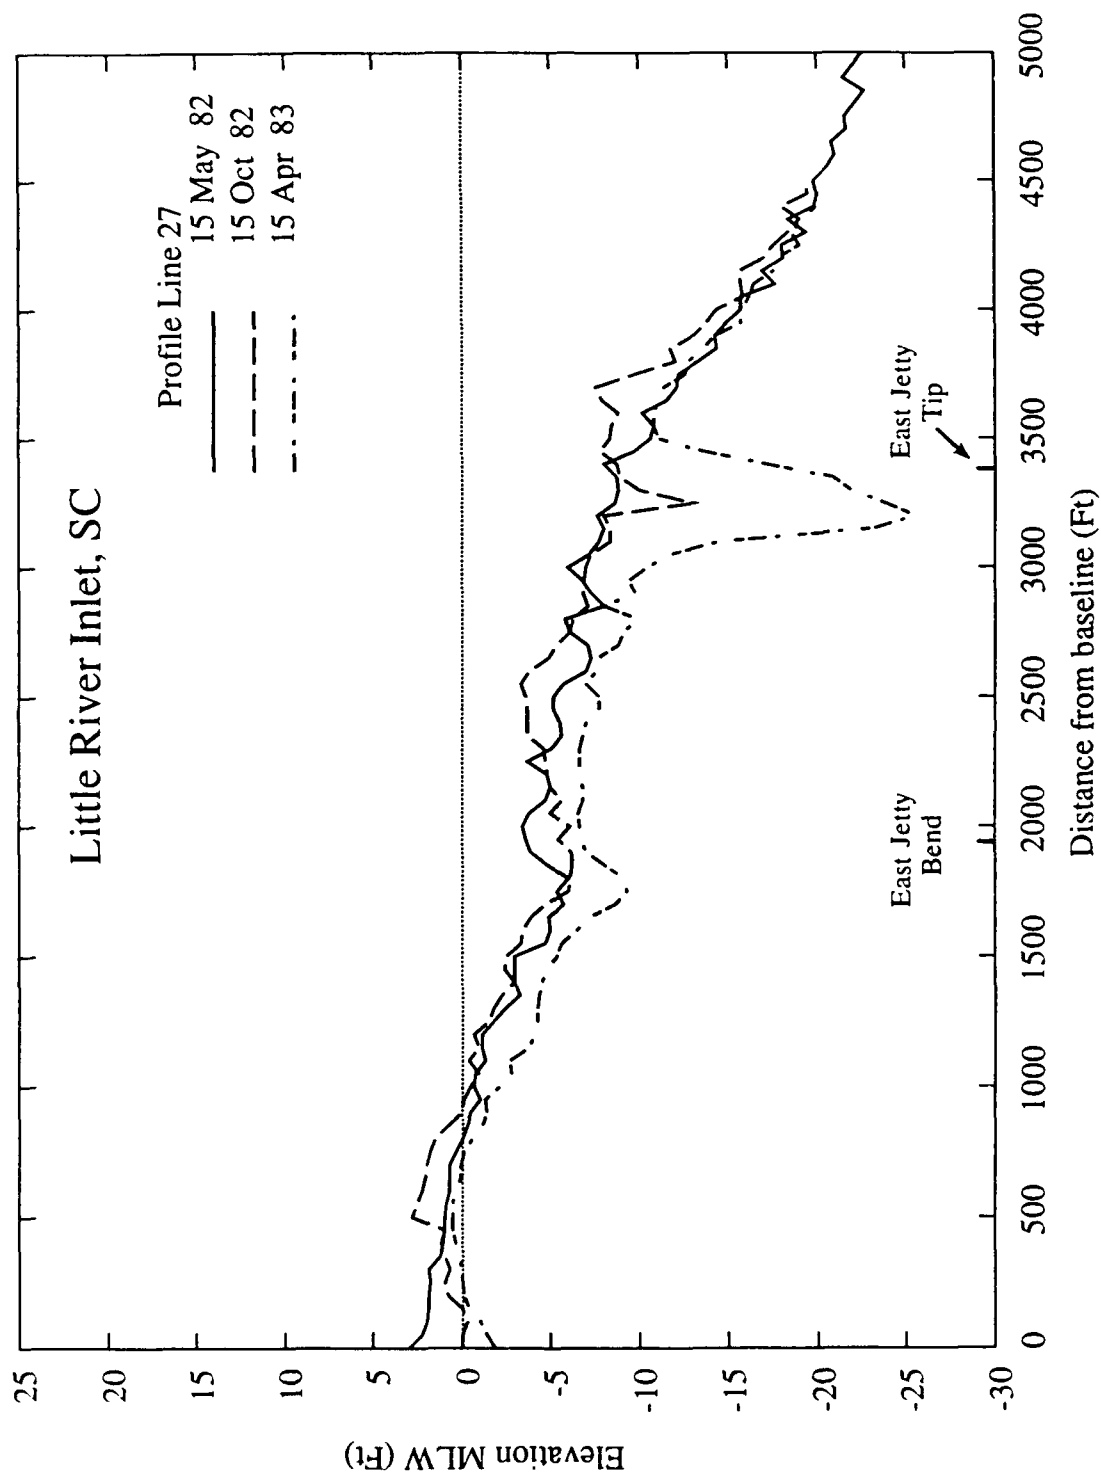
Figure 58. Profile along inside of east jetty: May 1982 to April 1983

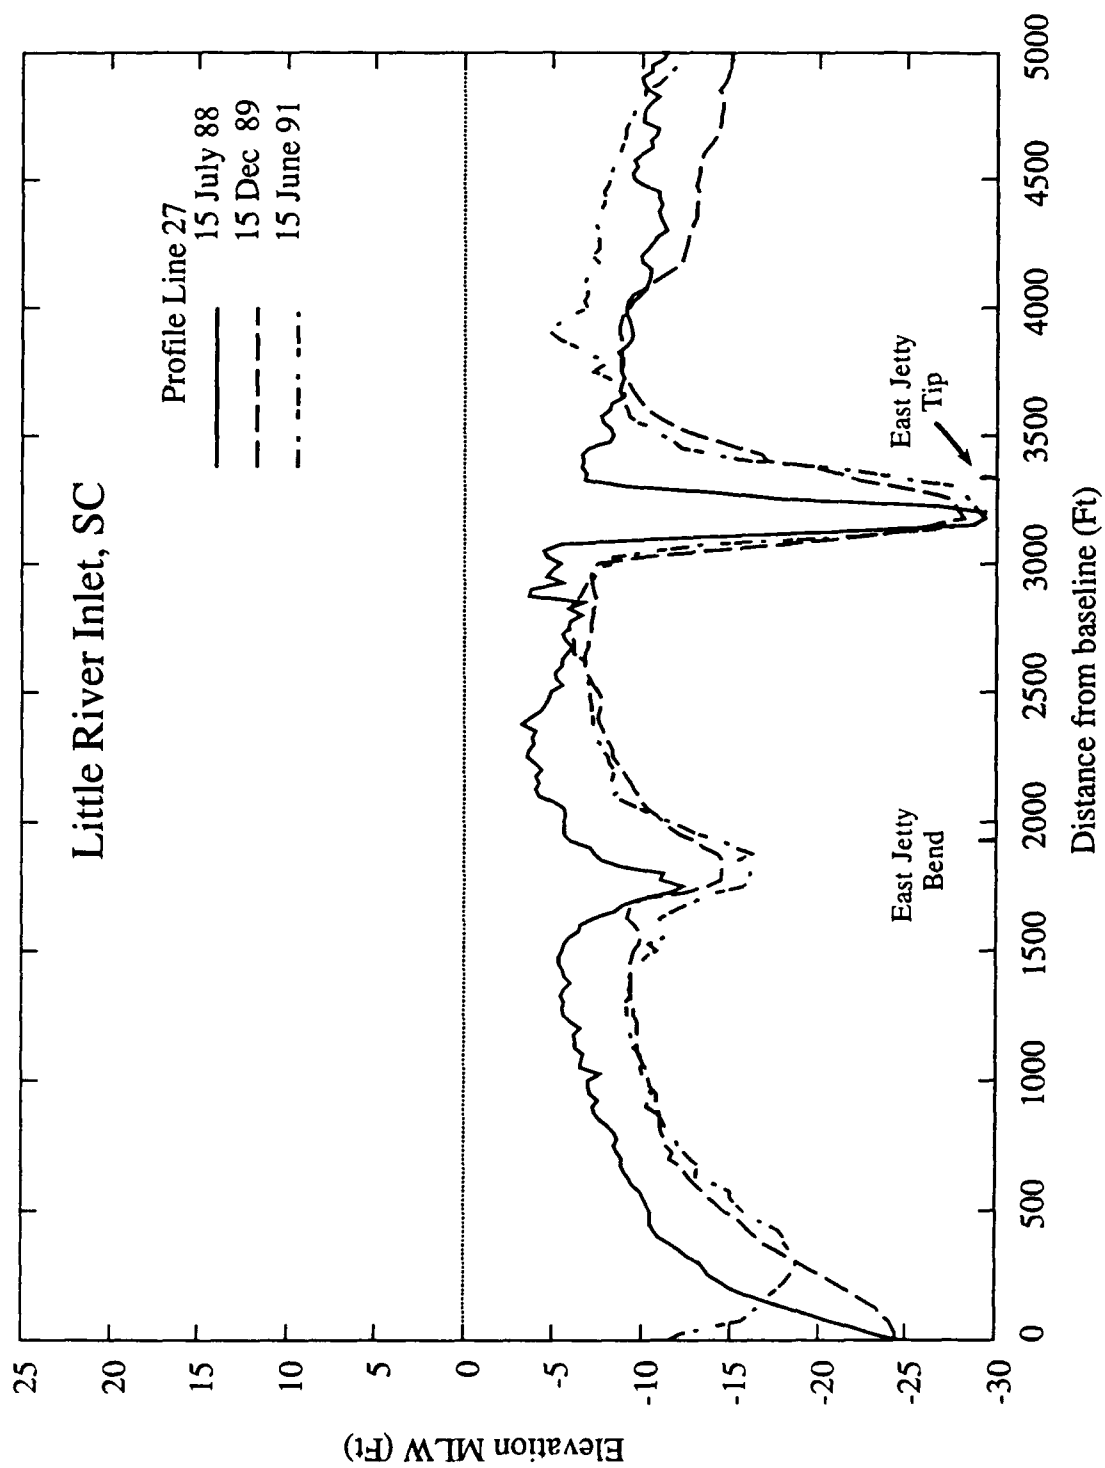
Figure 61. Profile along inside of east jetty: July 1988 to June 1991

the tip of the east jetty and varies in depth between -5 and -12-ft MLW (Figures 61 and 63). The close proximity of the ebb shoal to the tip of the jetty also may be resulting in increased channelization of flood tidal flow through the scour hole.
